**CLASS 150 ASBESTOS CEMENT (AC)
WATERMAIN PIPE
CONDITION EVALUATION
DEEP BAY WATER DISTRICT**

The Deep Bay Waterworks District
5031 Mountainview Road
RR1, Site 150, C 4
Bowser, British Columbia
V0R 1G0

Levelton Consultants Ltd.
150 - 12791 Clarke Place
Richmond, B.C.
V6V 2H9

11 December 2008

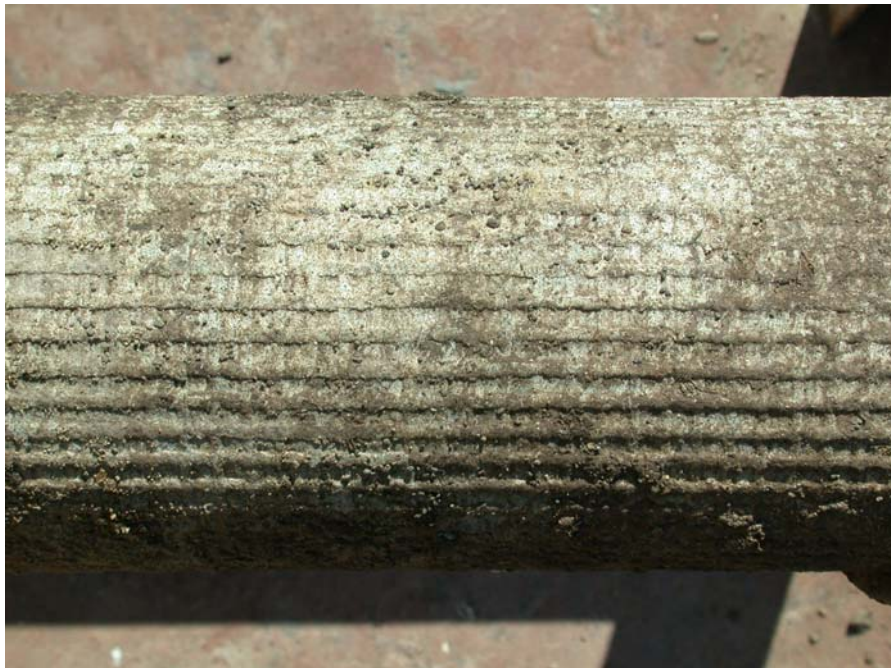
Figure 2: Close-up view of AC pipe Sample X-87 (Lot 10, Shoreline Drive) in the as-received condition, showing adhered dirt and sand and the heavy waffle pattern on the sample external diameter surface.

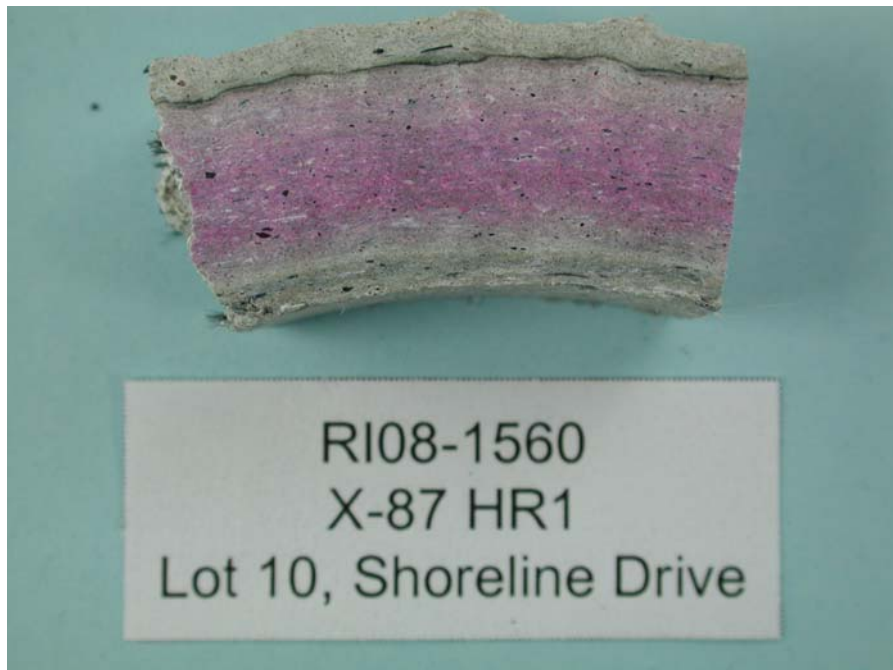
- The sub-samples taken from both the end and hydrostatic ring sections of AC pipe Sample X-87 (Lot 10, Shoreline Drive) appeared to demonstrate cement mortar leaching on both internal and external diameter surfaces.

Figure 14: View of Sub-sample X-87 HR1 shown in Figure 12 after polishing and phenolphthalein indicator "staining" (hydrostatic fracture shown at left). The pink colouration indicates a band of unleached (sound) pipe wall.
