September 28, 2009

2360-001/01

**Re: Deep Bay Water Tank  
Preliminary Review of Cracking in Tank Walls**

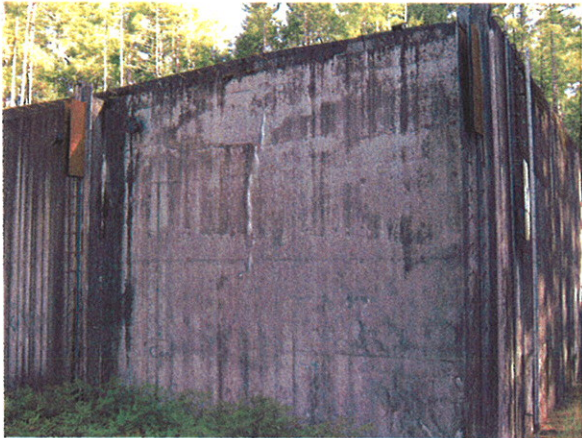
The general concrete surface of the tank appears in reasonable condition. There are some cracks which are leeching salts which are midspan of the tank and may require repair.

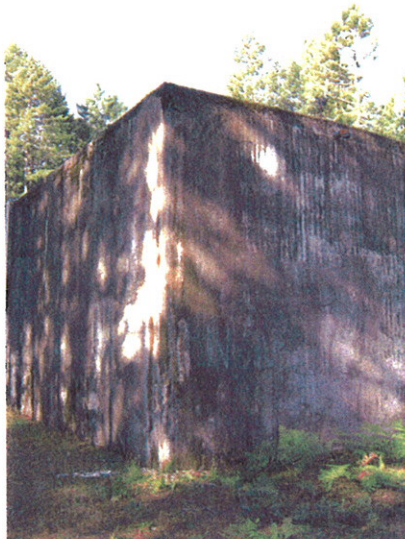
No spalling could be seen and the significant defects appear confined to the corners of the tank. It is understood that these defects are not evident on the inside of the tank; however it is recommended that a review of the interior be made to confirm this as it may help define the appropriate repair strategy.

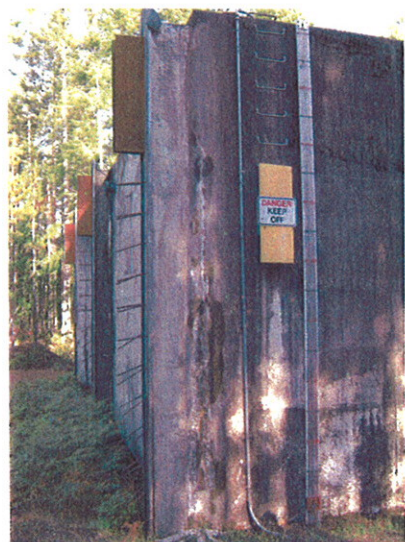
The defects also coincide with what appears to be previous concrete repair work. It is understood from the board that there is some record of these repairs being carried out in around 2001.

The defects are in the form of cracking and spalling of the repair which appears to have been done to address cracking to the original concrete.

The repairs made around 2001 are beginning to delaminate and there is seepage through the walls at these points with significant efflorescence. The wet concrete in these locations is therefore vulnerable to freeze/thaw action and it is expected to get worse each winter. There is also parging around the repairs which is delaminating and appears to have been done to surface protect the repair and cover and defects in the concrete surface. This is particularly evident on the north wall of the tank.

As far as could be ascertained from a visual inspection, there did not appear to be any spalling as a result of reinforcing corrosion and the defects appear related to original construction/ detailing issues at the corners (likely shrinkage or thermal cracking at the corners of the tank where the associate stresses would be high).

Ideally the cracks would be repaired both inside and outside of the tank. The interior repairs would prevent the water penetrating the concrete with the exterior repair being the impermeable barrier. It is considered better to stop the water penetrating the cracked concrete as early as possible and then the exterior repairs can be cosmetic. This would require a review of the inside of the tank to identify any cracking.

In some cases, the concrete is cracked to a point where the concrete needs replacing (lower north east corner) as a patch or crack repair would be uneconomic due to the volume of material required.
