February 12th, 2024

2360-002

**Re: Deep Bay Improvement District - Water Tank
Condition Assessment**

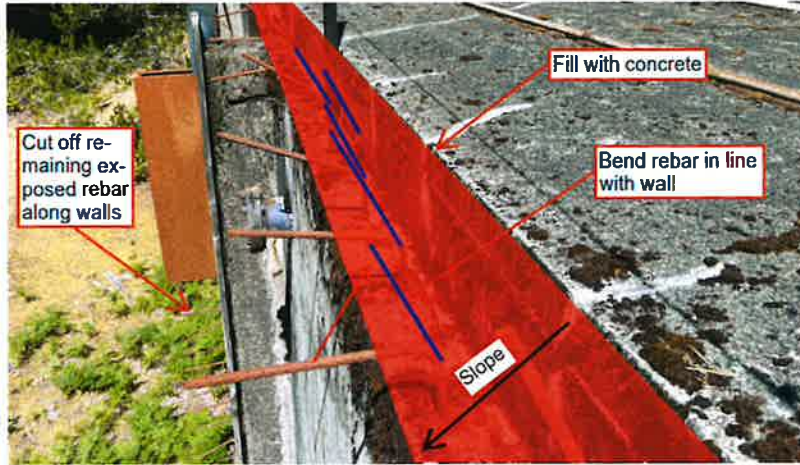
Figure 1: Proposed South Wall Repair

Another source of water ingress into the concrete may be along the top of the south wall at the existing roof-wall connection where a notch and exposed rebar was built into the tank, reportedly to facilitate a future addition. If it is unlikely that any future additions to the tank will be carried out, it is recommended that the exposed rebar on the top south wall be bent parallel with the wall and additional concrete be placed to allow water to drain away from the structure. Furthermore, the exposed rebar projecting from the walls can be cut away. This work is expected to cost approximately \$5,000 – 10,000. Figure 1 describes this repair.

3. Install flexible sealant in the joint and cracks.
4. Apply a membrane, either flexible or cementitious, inside the tank.
5. Apply a 2-ply SBS membrane to the roof of the tank.
6. Fill the notch along the top of the south wall with concrete as described in Figure 1.

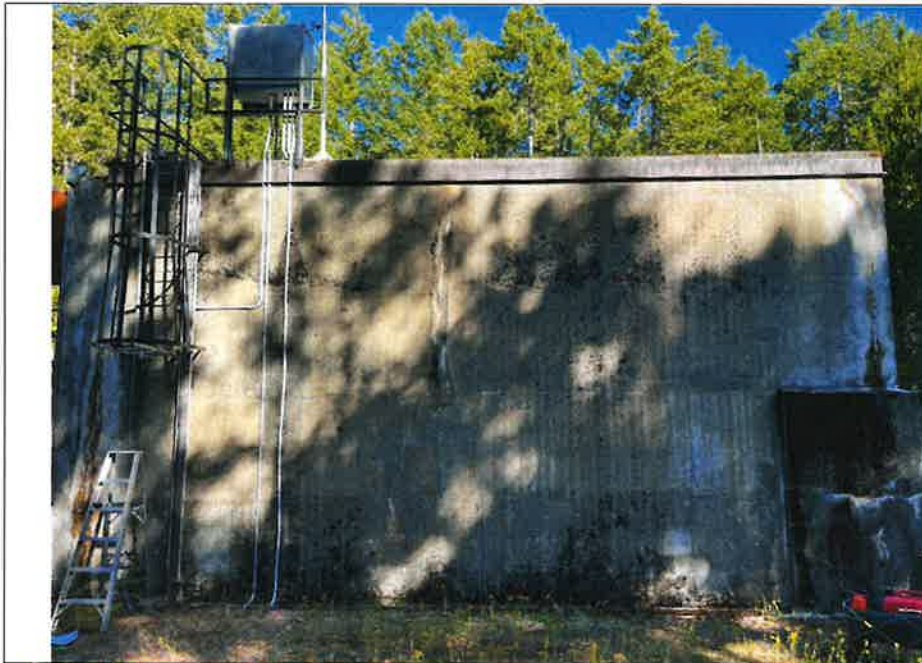
1. Vertical cracks on the walls were observed on each side of the four corners of the building (see Photos 1-4).
2. Vertical cracks were also observed in the center of all but the west wall (see Photos 1-4).

3. It was noted that many exterior cracks have previously been repaired with a cementitious parging applied to the exterior surface of the tank. However, many of the previously repaired cracks appear to be leaking.

Photo 1 – A view of east side of the water tank. Note the vertical cracks near the corners as well as in the center.

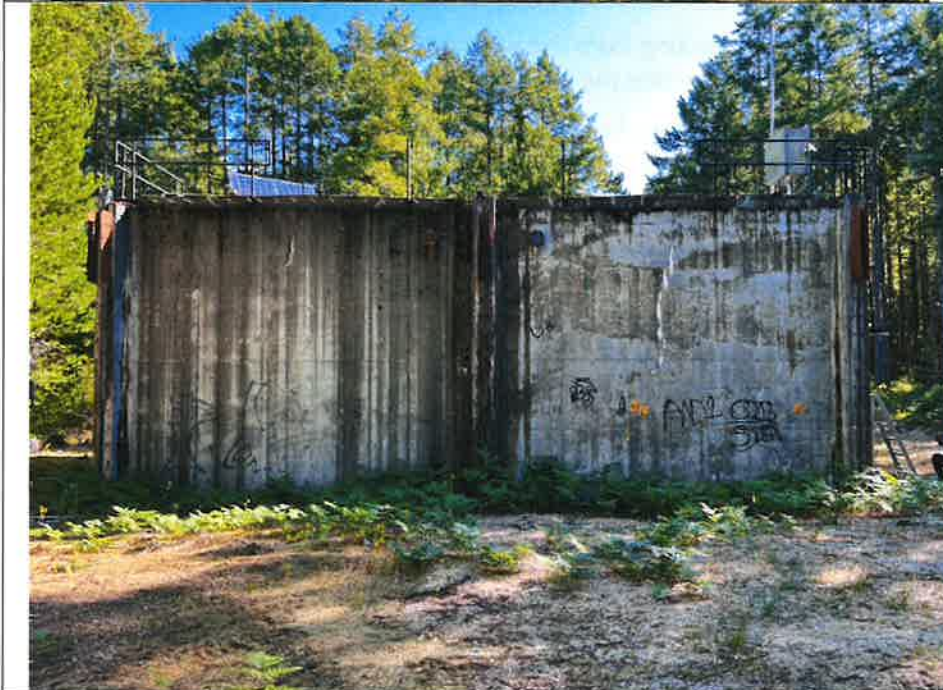
6. Exposed reinforcing steel was observed to be still present on the south side of the tank projecting out of the roof slab and walls. This was reportedly left to facilitate the future expansion of the tank's capacity (see Photos 2, 6, & 7).

Photo 2 – A view of the south side of the holding tank. Note the vertical cracks near the corners as well as in the centers.

1. Remove the exposed rebar projecting from the walls on the south side of the tank.
2. Engage a water specialist to determine the sources of water contamination.

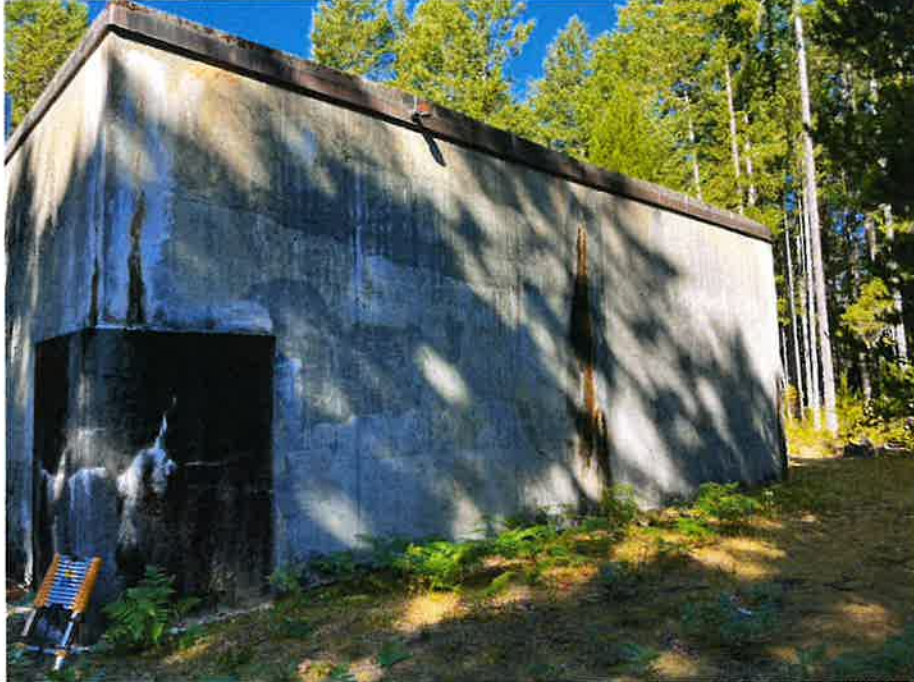
Photo 3 – A view of the north side of the holding tank. Note the vertical cracks near the corners as well as in the center.

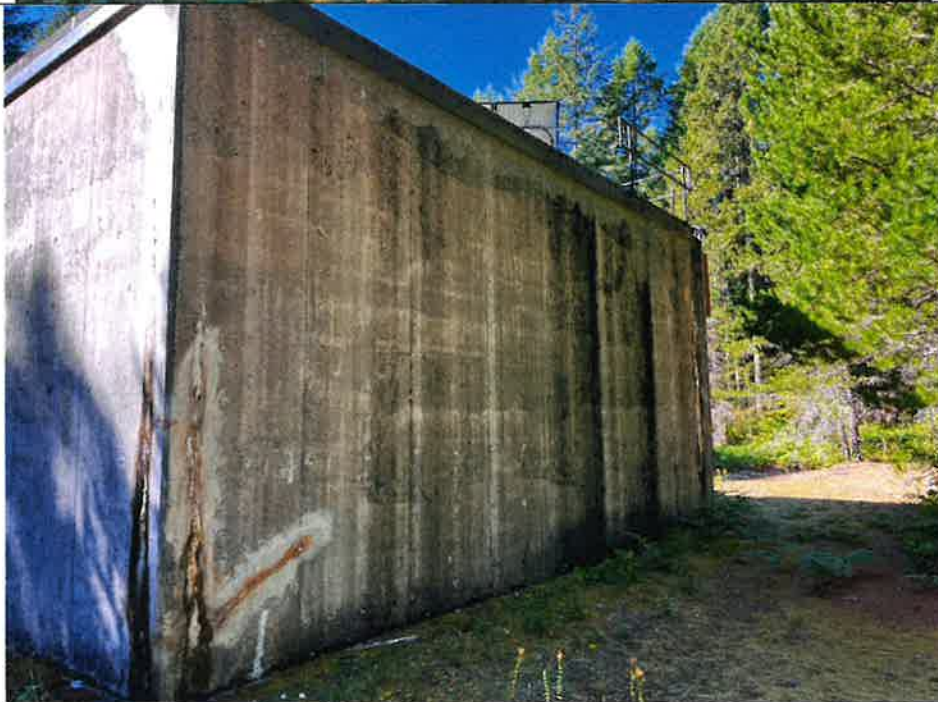
Photo 4 – A view of gauge the west side of the holding tank. Note the vertical cracks near the corners.

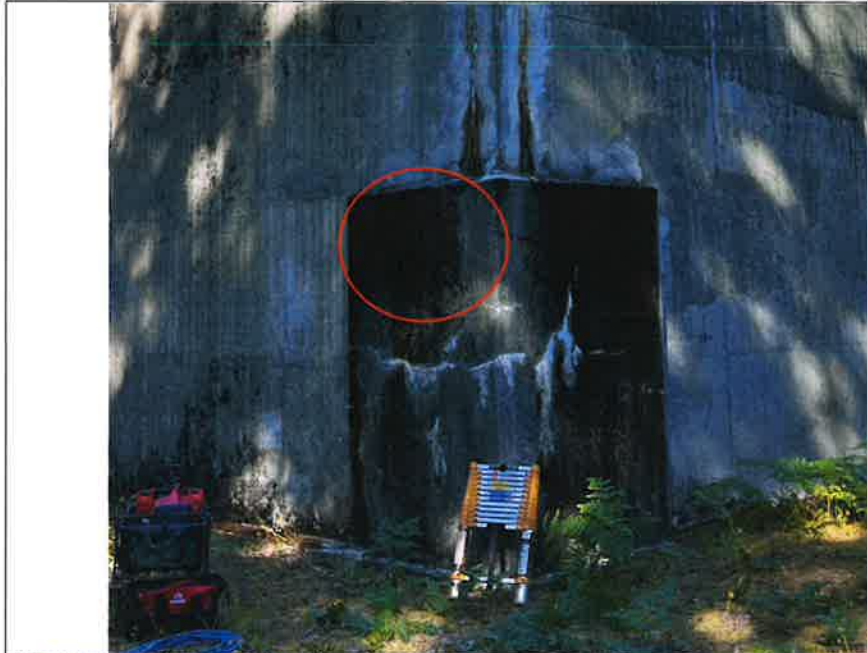
4. The cementitious parging was noted to be poorly bonded to the concrete walls in many locations.
5. It was observed that a previous repair to the north-east corner had been completed that involved thickening the concrete wall from the top of the footing to approximately 6' high and wrapped 5' wide in each direction around the corner (see Photo 5). It was noted that the top east face of this repair appears delaminated when sounded.

Photo 5 – A view of the existing repair on the north-east corner of the water tank. The red circle indicates the approximate extents of the delamination.

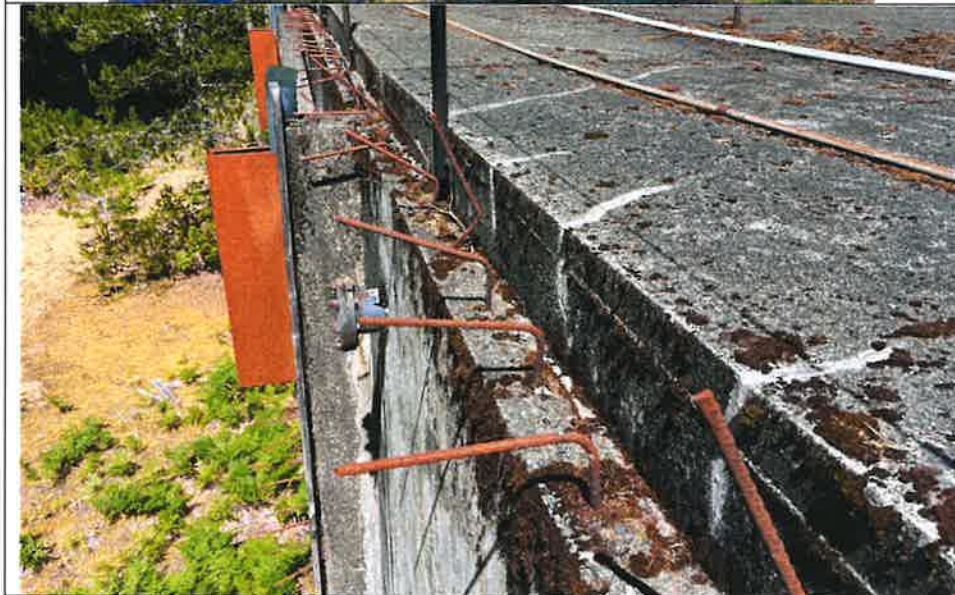
Photo 6 - A view of the exposed rebar on the south side of the water tank.

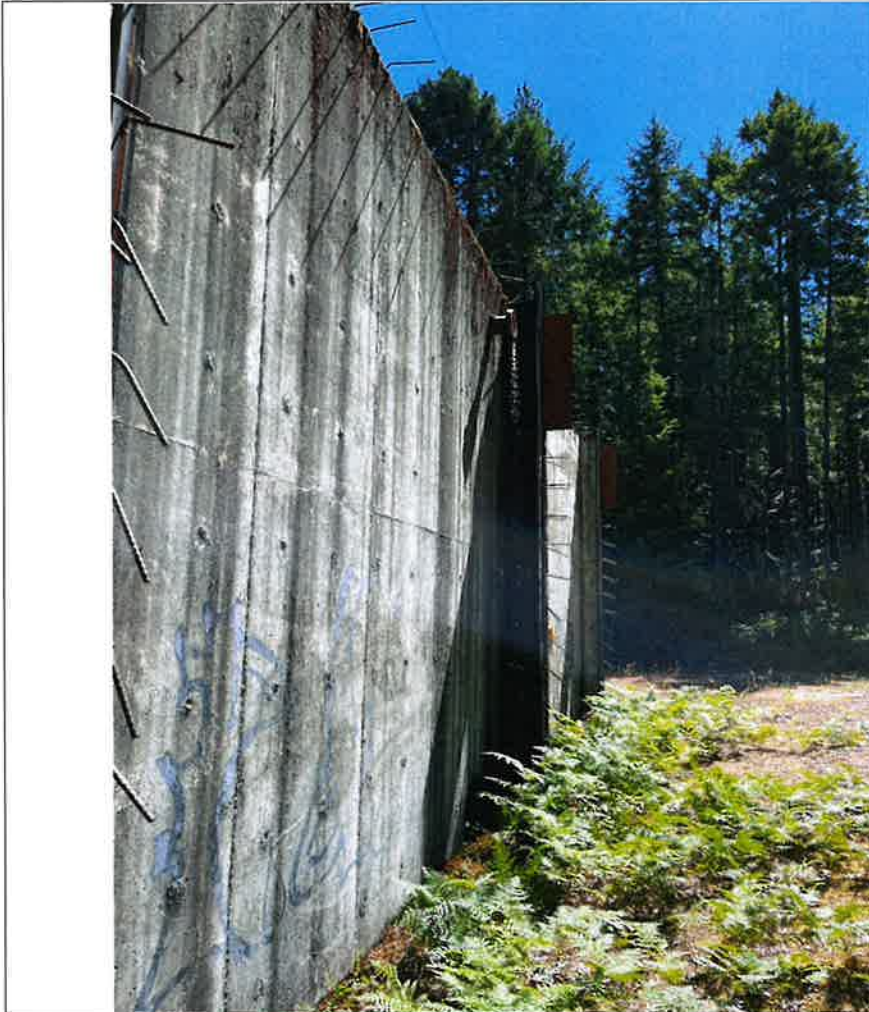
Photo 7 – A view of the exposed rebar on the south side of the water tank.

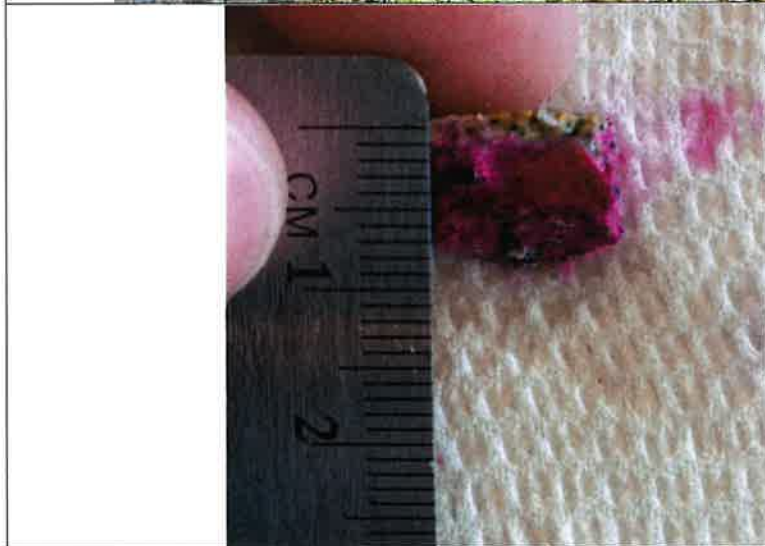
It is noted that since the depth of carbonation is less than the concrete cover, it is unlikely that concrete carbonation is cause for deterioration.

Photo 8 – Carbonation Test #1 where the pink colour indicates where the concrete is not carbonated and the absence of colour indicates the presence of carbonation.

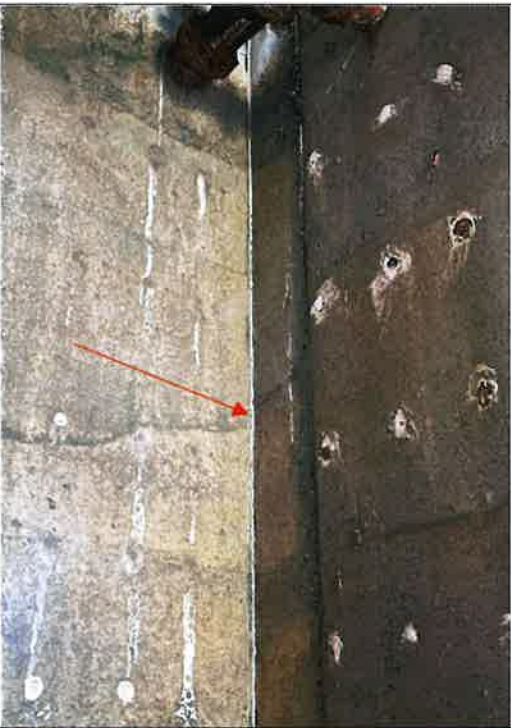
8. Vertical cracks were observed at each of the four interior corners of each tank some spanning the entire height (see Photos 11 and 12)
 - a. These cracks ranged from 1-4 mm in width.

<p>Photo 11 – A view of the interior south-east corner of west tank. Note the top half of the corner appears to feature a crack.</p>

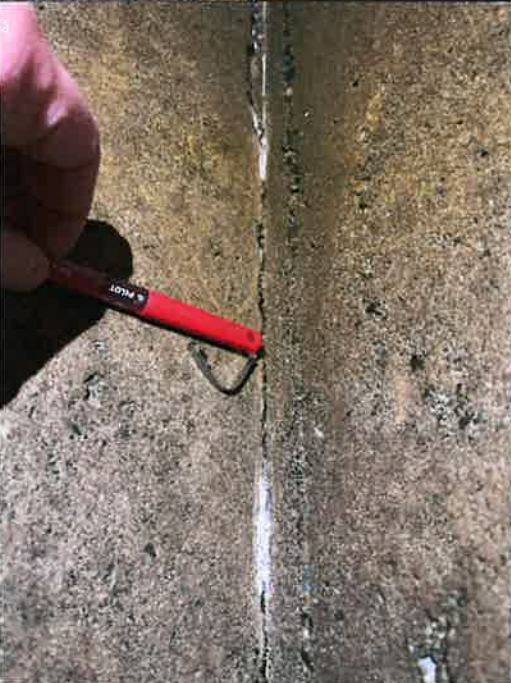
<p>Photo 12 – A close view of a typical crack in the tank corners.</p>

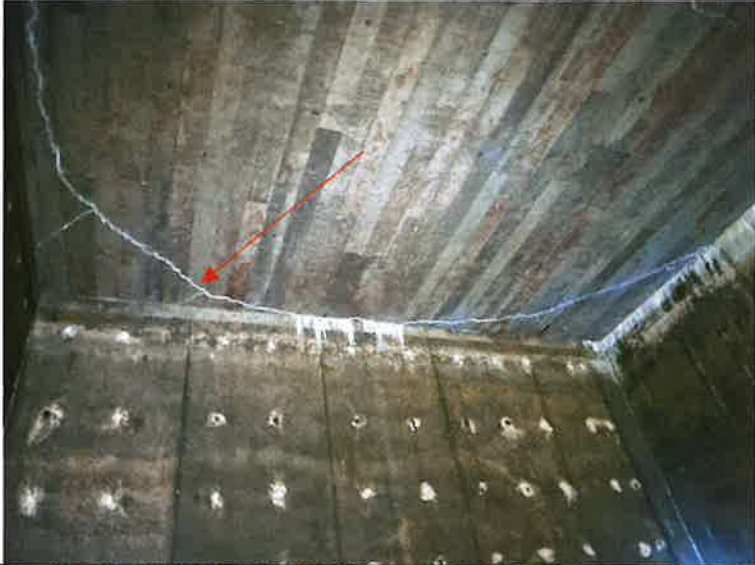
9. Cracks were observed on the roof of the tank which were also noted to be visible from the inside of the tank (see Photo 13 as an example).
10. Erosion to the concrete was observed inside the water tanks (see Photo 14 & 15 examples).

<p>Photo 13 – An example of a crack in the roof of the tank which is visible from the inside of the tank. Shown is the north side of the west tank.</p>

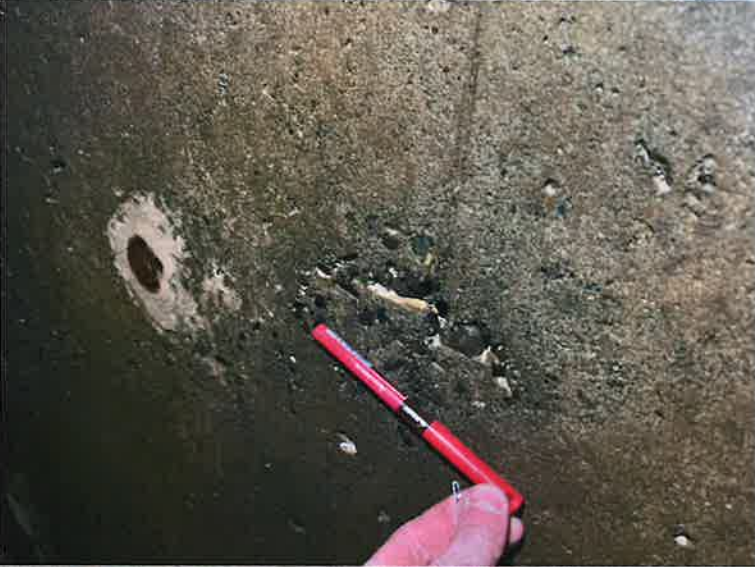
14. While sounding the concrete inside the tank, it was noted that the concrete exhibited a dull sound. This is likely an indication of a weak surface layer of concrete, perhaps 3-5mm deep, which may have resulted from the cement dissolving due to prolonged exposure to fresh water.

<p>Photo 14 – An example of concrete erosion observed inside the tanks.</p>

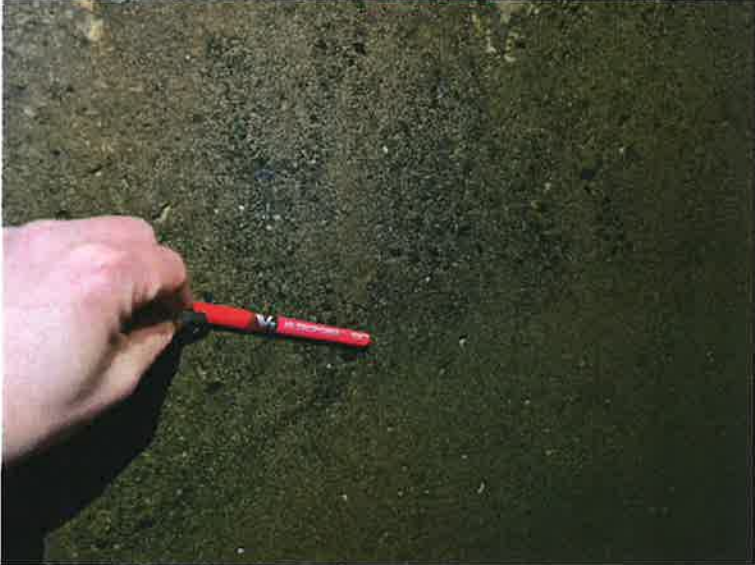
<p>Photo 15 – An example of concrete erosion observed inside the tanks.</p>

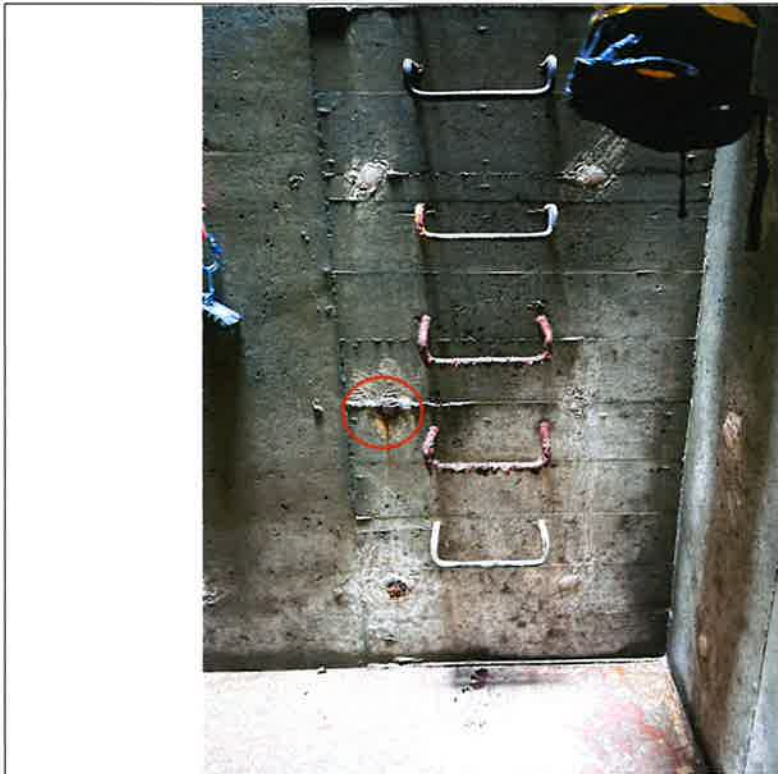
11. Corrosion of the existing concrete form ties was observed (see Photos 16).
12. It was noted that some of the ladder rungs providing access to the interior of the tanks have experienced minor corrosion (see Photo 16).

Photo 16 – A view of the corroded ladder in the west tank. A corroded form ties is also visible (circled in red).

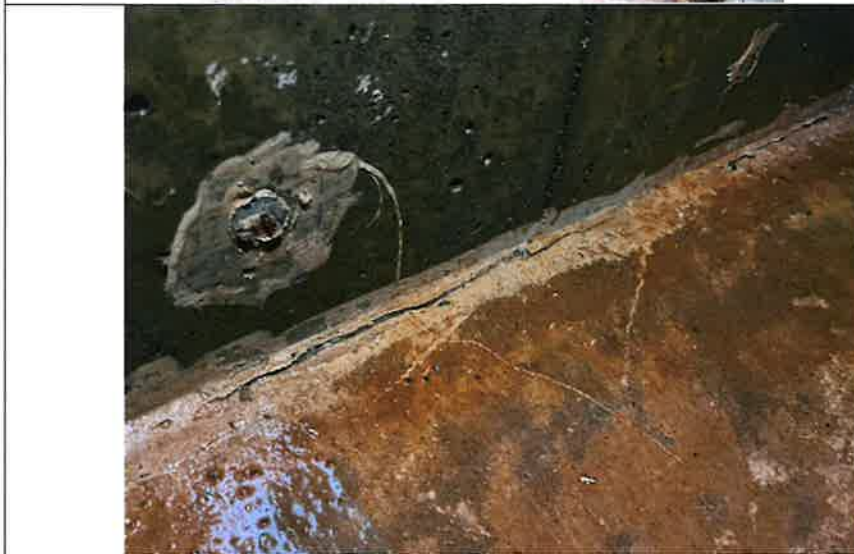
13. Cracks were observed between the bottom of the tank and the tank walls.
 - a. It was noted that these cracks had been previously repaired in the east tank, however, these repairs appear to be cracked (see Photo 17 as an example).

Photo 17 – An example of a failed crack repair between the bottom of the tank and the tank wall.
