# TECHNICAL MEMO

<b>To</b> John Marsh, CPA, CMA, Administrator Deep Bay Improvement District	<b>From</b> Nathan Slater, P.Eng., Project Engineer
<b>Re</b> Deep Bay Improvement District – Asbestos Cement Pipe Replacement	<b>Date</b> April 14, 2023

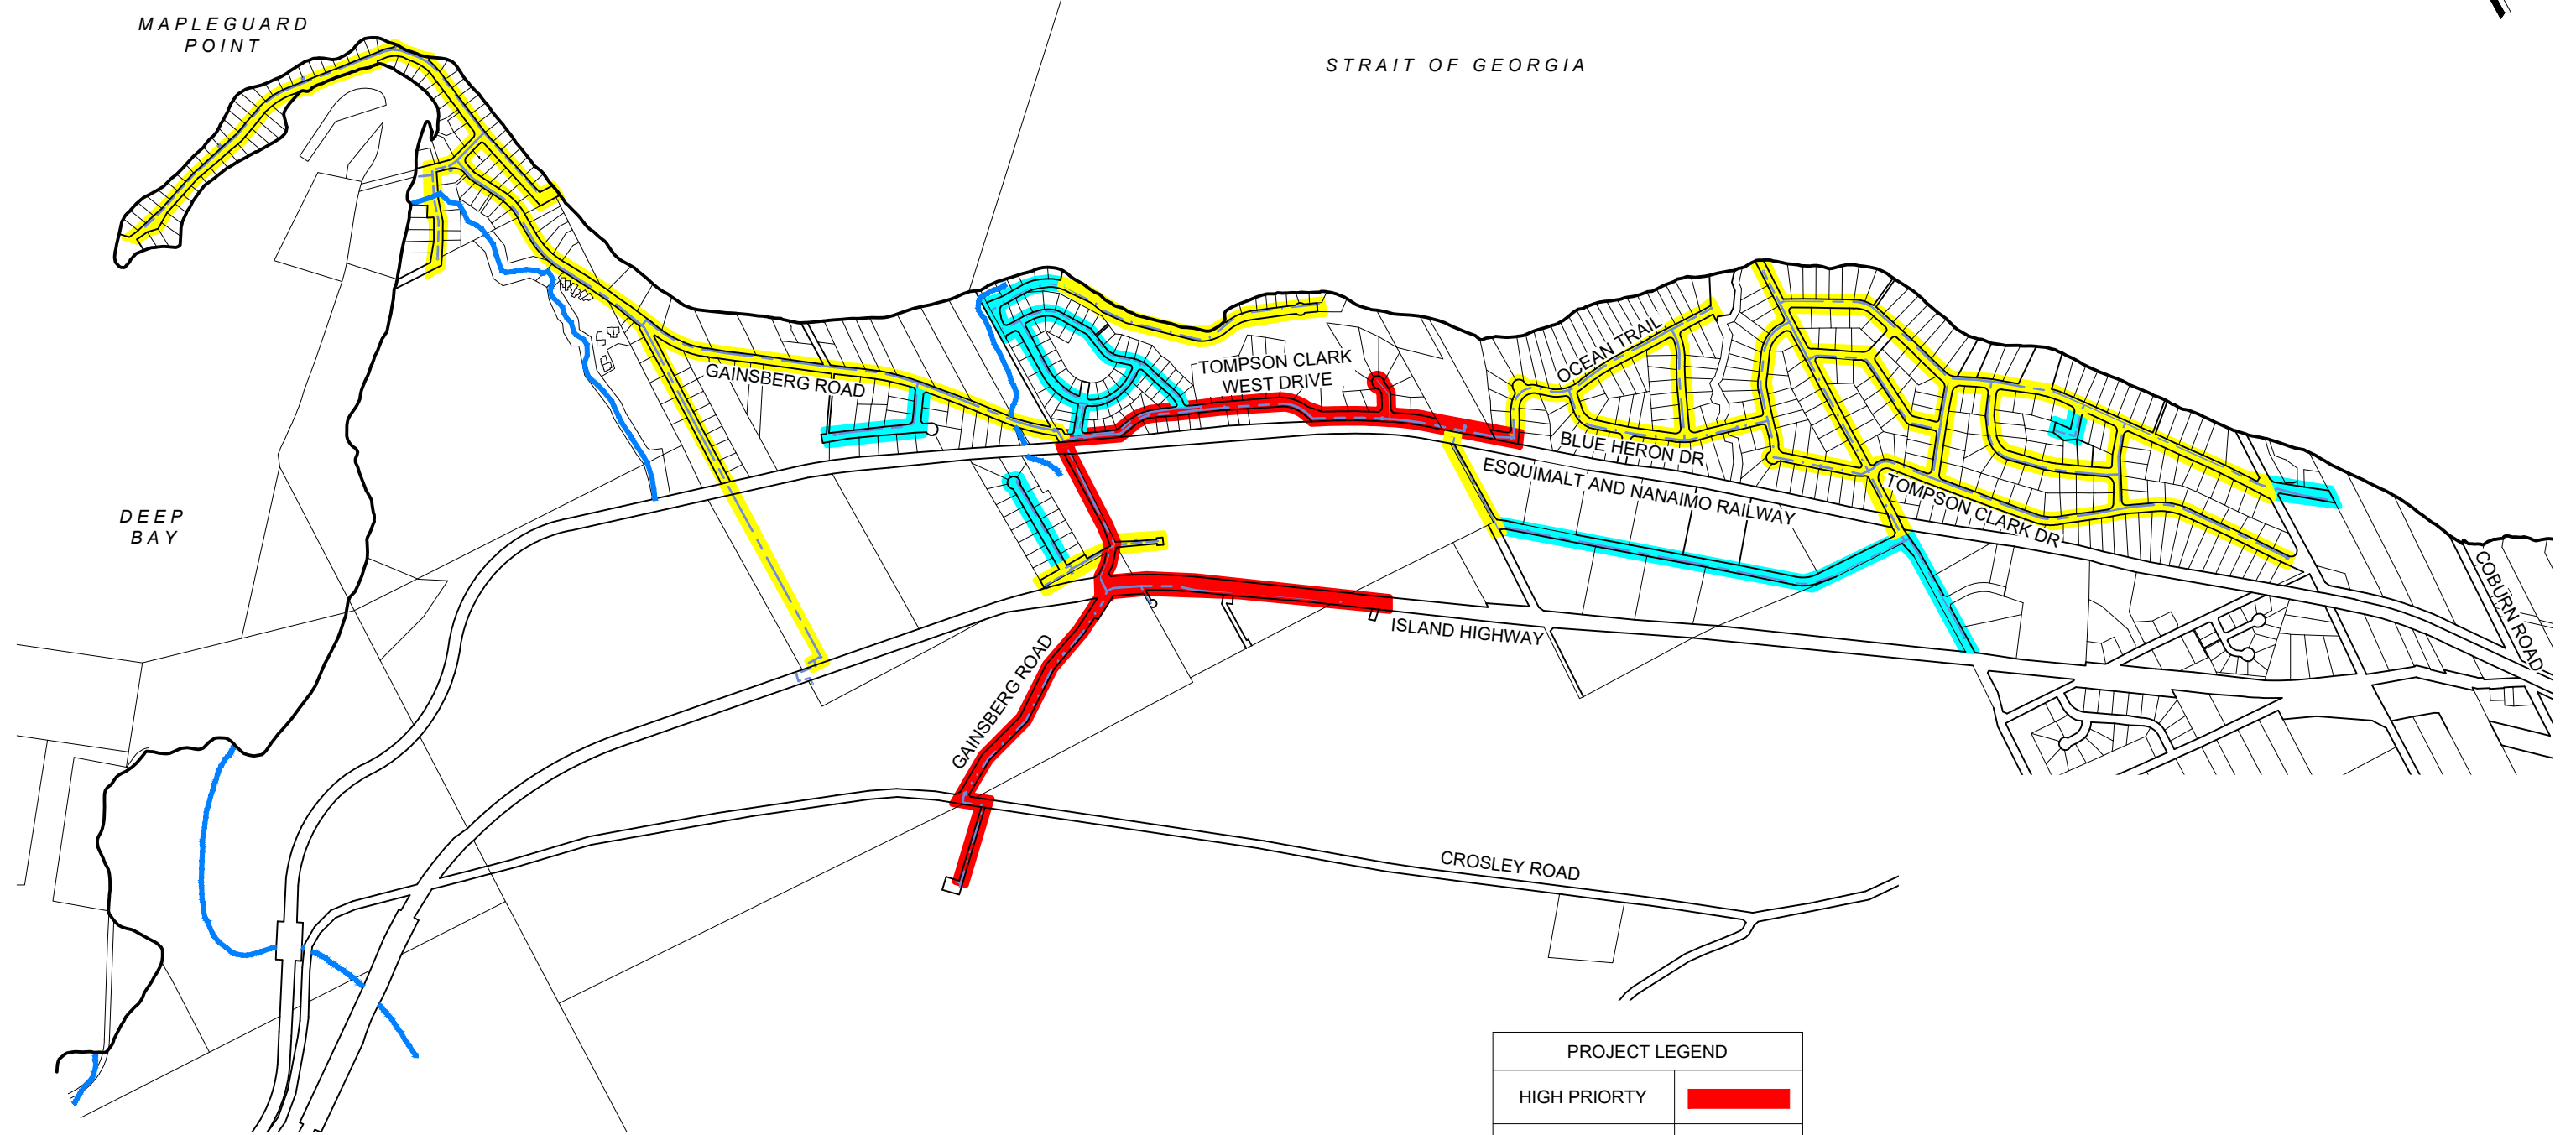
Drawing No.	<b>FIG 1.0</b>
Project Number	2231-27316-01
Rev.	PA

The locations identified as the highest priority are summarized as follows:

Location	Start	End	Asset Rating	Class “D” Estimated Replacement Cost
Thompson Clark West	Lot 44	Ocean Trail	13	\$587,000
Gainsberg Road	Thompson Clark West	Mountain View Road	12	\$437,115
Gainsberg Road	Mountain View Road	Reservoir	12	\$1,436,925
Island Highway	Gainsberg Road	Well No. 5	12	\$630,557
Island Highway	Well No. 5	Well No. 8	12	\$247,699
Thompson Clark West	Gainsberg Road	Kopina Drive	12	\$85,000
Thompson Clark West	Seaview Drive	Melvin Crescent	12	\$626,532
Thompson Clark West	Melvin Crescent	Lot 44	12	\$218,558
Thompson Clark West	Kopina Drive	Seaview Drive	11	\$480,827
