**CLASS 150 ASBESTOS CEMENT (AC)
WATERMAIN PIPE
CONDITION EVALUATION
DEEP BAY WATER DISTRICT**

The Deep Bay Waterworks District
5031 Mountainview Road
RR1, Site 150, C 4
Bowser, British Columbia
V0R 1G0

Levelton Consultants Ltd.
150 - 12791 Clarke Place
Richmond, B.C.
V6V 2H9

11 December 2008

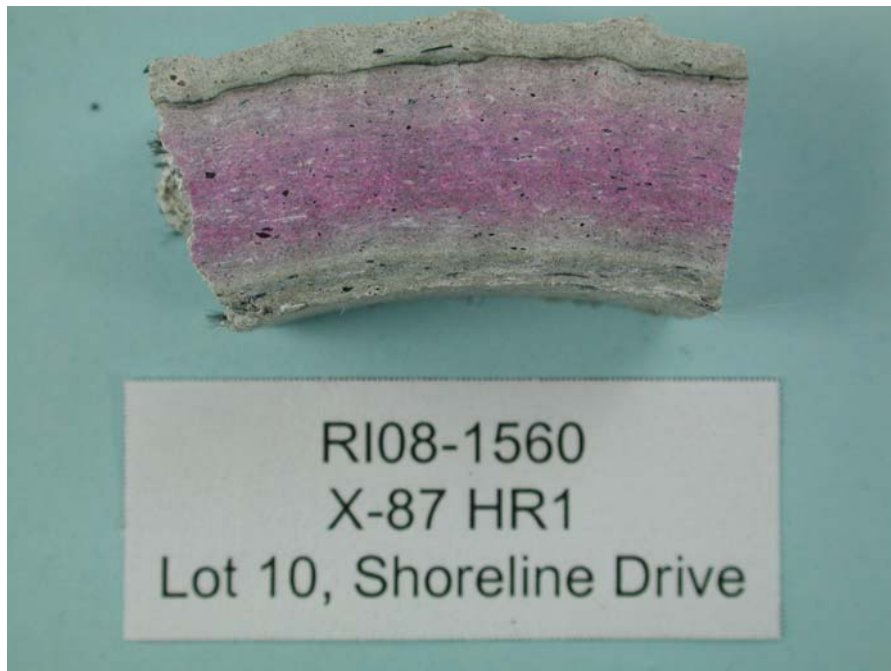
Figure 15: View of Sub-sample X-87 R1 shown in Figure 13 after polishing, phenolphthalein indicator “staining”, drying and marking for SED/EDS analysis.
