DEEP BAY IMPROVEMENT DISTRICT

ANNUAL WATER SYSTEM REPORT 2015

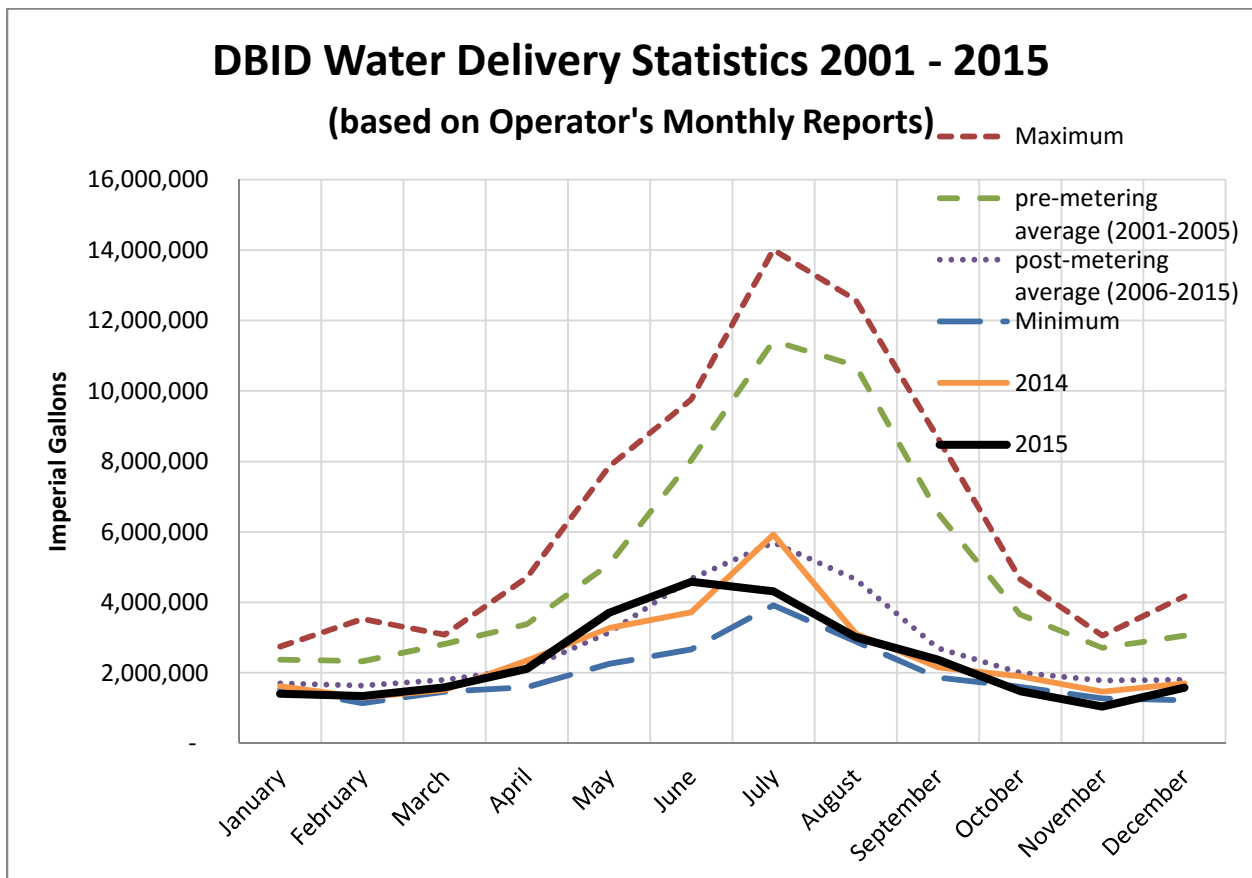
The following graph shows the monthly water delivery figures from the DBID wells. Overall, water delivery for 2015 was below the post-metering average. Consumption in some of the spring and summer months was slightly higher than the post-metering average. Given the dry conditions that were experienced over the summer months, rate payers are to be commended for their careful use of water.

DBID conducts a water audit after each quarterly meter reading to compare the amount of water pumped, as measured at the wells, vs. the amount of water delivered through the water meters. The average difference for 2015 was 15.47% up from 12.51% in 2014. This difference is accounted for by water used for flushing (hydrants and reservoir), water used for fire protection purposes, and undetected water loss in the system. In the first quarter of 2015 an extensive hydrant flushing was undertaken accounting for some of the increase seen from 2014. Typical loss in a water system is 10-15%.
