DEEP BAY IMPROVEMENT DISTRICT

ANNUAL WATER SYSTEM REPORT 2016

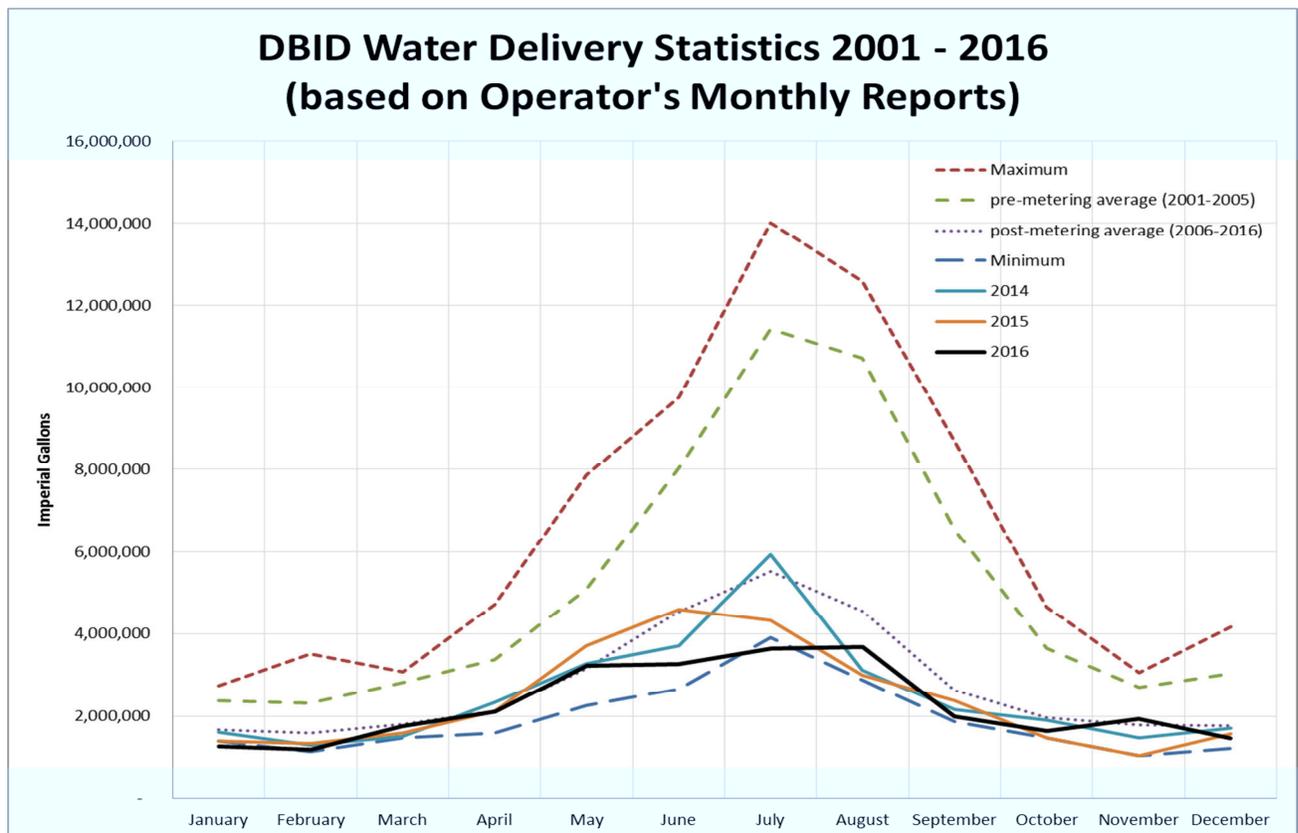
The following graph shows the monthly water delivery figures from the DBID wells. Overall, water delivery for 2016 was below the post-metering average. Consumption in the summer quarter (July – September) was well below average due to higher than usual rainfall levels. The district has been experiencing a decrease in overall consumption over the past several years and 2016 continued this trend.

DBID conducts a water audit after each quarterly meter reading to compare the amount of water pumped, as measured at the wells, vs. the amount of water delivered through the water meters. The difference for 2016 was 13.01% down from 15.47% in 2015. This difference is accounted for by water used for flushing (hydrants and reservoir), water used for fire protection purposes, and undetected water loss in the system. In the last quarter of 2016, extensive flushing was undertaken as part of the required shock chlorination. Typical loss in a water system is 10-15%.
