DEEP BAY IMPROVEMENT DISTRICT

ANNUAL WATER SYSTEM REPORT 2019

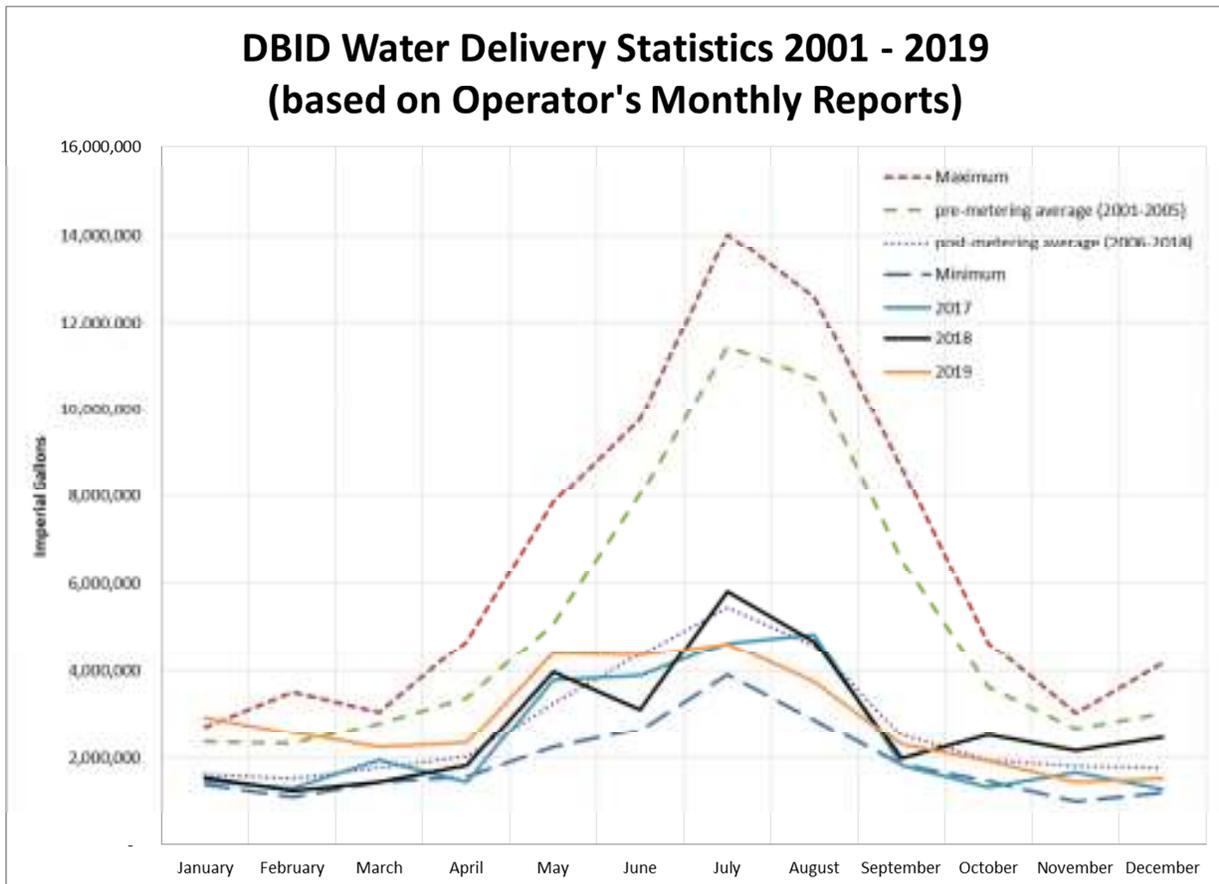
DBID Water Delivery Statistics (first graph on next page) show the water pumped from the wells each month. This does not correlate directly to water consumption measured at the meters as it also includes all distribution system flushing, hydrant use and water used during routine repairs and maintenance.

Water production was higher in 2019 than 2018 due to a number of reasons. Early in 2019, a major leak was suspected based on high pumping numbers. The leak was found (a break on a 6" main) and repaired in March. In September, DBID performed a shock chlorination. Procedures for this involve partially emptying and refilling the reservoir and pulling water throughout the distribution system through systematic flushing of hydrants. Additionally water consumption, as recorded by the quarterly meter reads, has also been increasing.

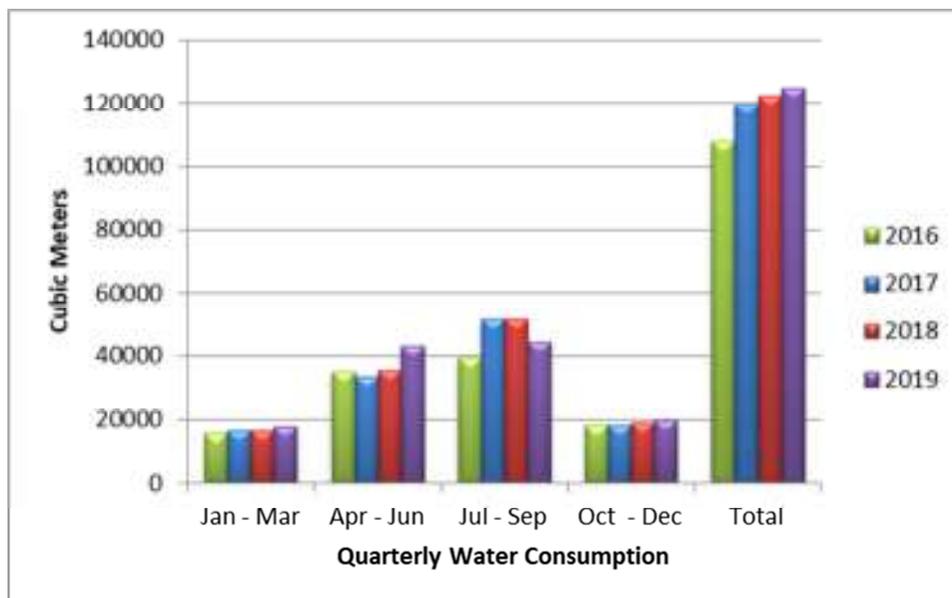
Quarterly Water Consumption (second graph on next page) reflects usage measured by the quarterly meter reads and shows a slow but steady increase in consumption over the last few years.
