DEEP BAY IMPROVEMENT DISTRICT

ANNUAL WATER SYSTEM REPORT 2017

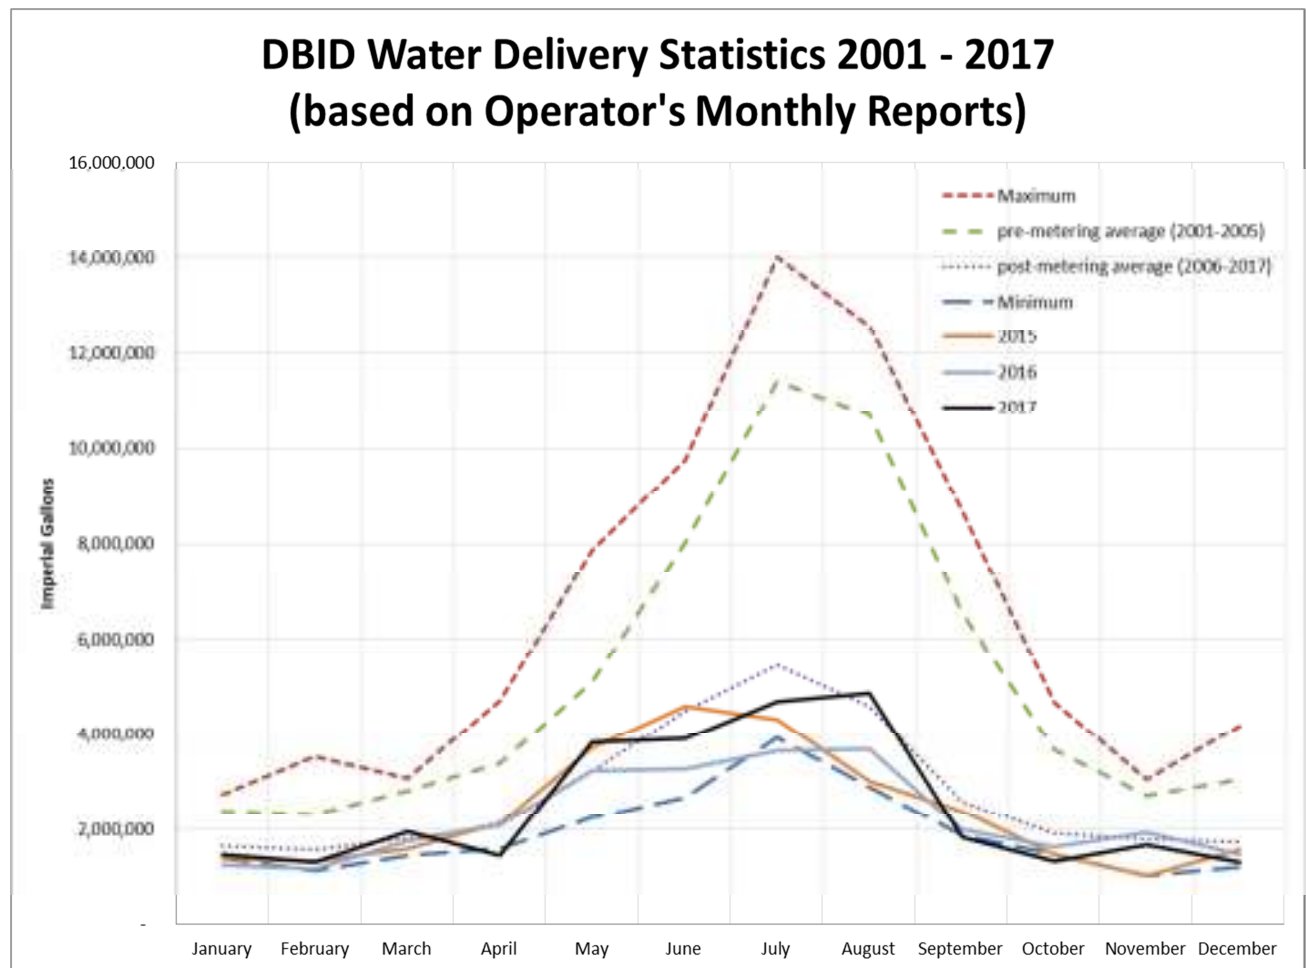
The following graph shows the monthly water delivery figures from the DBID wells. Water delivery for 2017 was marginally below the post-metering average and higher than 2016 due to the hot, very dry weather over the summer months. The district has been experiencing a decrease in overall consumption over the past several years and 2017 continued this trend with the exception of the peak summer usage.

DBID conducts a water audit after each quarterly meter reading to compare the amount of water pumped, as measured at the wells, vs. the amount of water delivered through the water meters. The difference for 2017 was 11.86% down from 13.01% in 2016. This difference is accounted for by water used for flushing (hydrants and reservoir), water used for fire protection purposes, and undetected water loss in the system. Typical loss in a water system is 10-15%.
